INDOOR AIR QUALITY REASSESSMENT

**Undermountain Elementary School
491 Berkshire School Road
Sheffield, Massachusetts**

Prepared by:
Massachusetts Department of Public Health
Bureau of Environmental Health Assessment
July, 2002

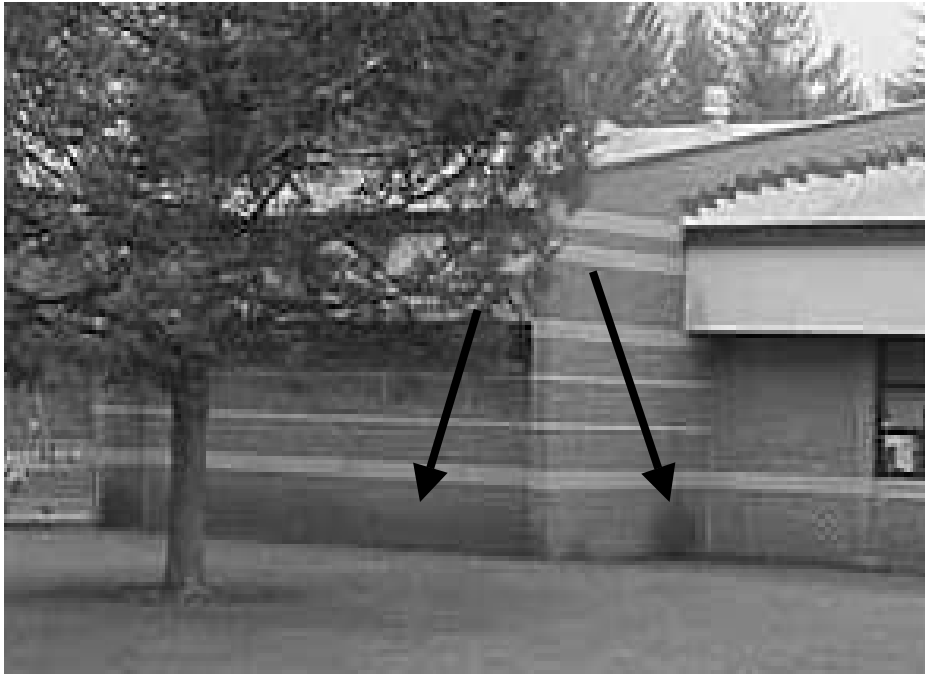
Picture 1

Of note was the absence of a gutter/downspout system along the peaked roof to direct rainwater from the base of exterior walls. After rainstorms, the exterior walls are saturated with moisture along some areas of the building (see Picture 1). Rainwater runs off the roof onto the ground at the base of the building. In one section equipped with a gutter/downspout system, rainwater was pouring from the gutter onto concrete (see Picture 2). Excessive water exposure to exterior brickwork can result in damage over time. During winter weather, the freezing and thawing of moisture in bricks can accelerate the deterioration of brickwork.

Exterior Wall Moistened During Rainstorm, Note Moisture Pattern at Base of Wall

7. Clean upholstered furniture on the schedule recommended in this report. If not possible/practical, remove upholstered furniture from classrooms.
8. Discontinue the use of tennis balls on chairs to prevent generation of latex dust.
9. Relocate or consider reducing the amount of materials stored in classrooms to allow for more thorough cleaning. Clean items regularly with a wet cloth or sponge to prevent excessive dust build-up.
10. Clean chalk boards and chalk trays regularly to avoid the excessive build-up of chalk dust.
11. Consider installing a gutter/downspout system on the edge of the peaked roofs of the building to direct water away from the base of the building. The installation of a drainage system may also be necessary to direct water away from the foundation.

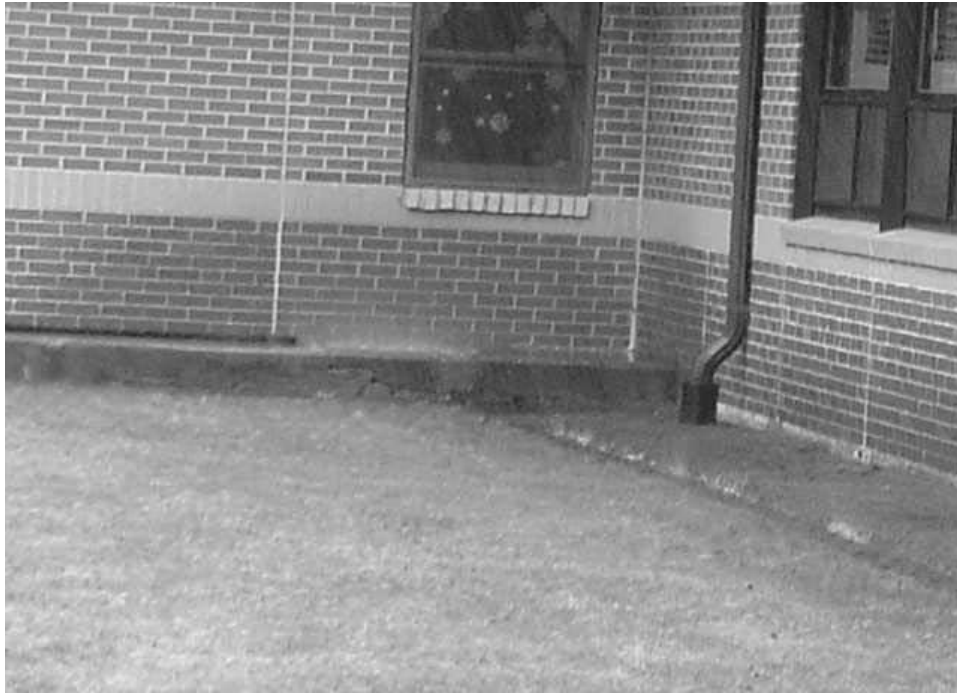
Picture 2

Splashing Rainwater below Flooded Gutter

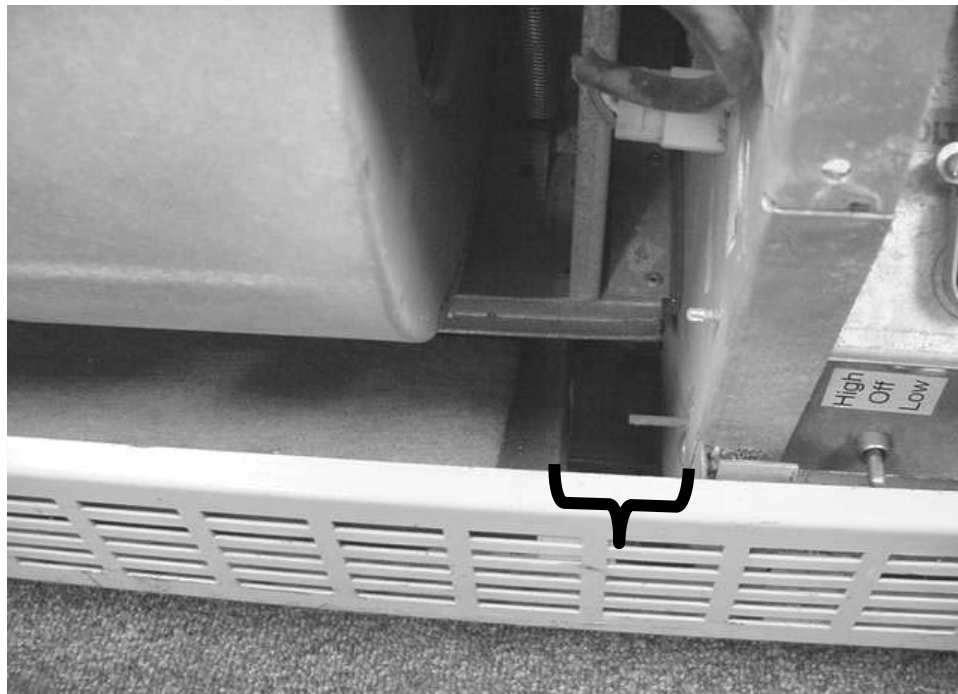
Picture 3

Univents were spot checked throughout the school complex. In some cases, the univent filter was removed from the univent and found to be smaller than the filter rack (see Picture 3).

Filters should be of sufficient size to fit flush into the entire filter rack. If filters do not fit flush with filter racks, air drawn into the univent will bypass filters and pass through spaces between filters and racks. This can result in dust, dirt and other debris being distributed by the ventilation system.

Short Filter Installed inside Univent, Note Space

3. Consider increasing the dust spot efficiency of filters to increase the removal of particulates from the environment. Ensure filters fit properly into their filter racks.

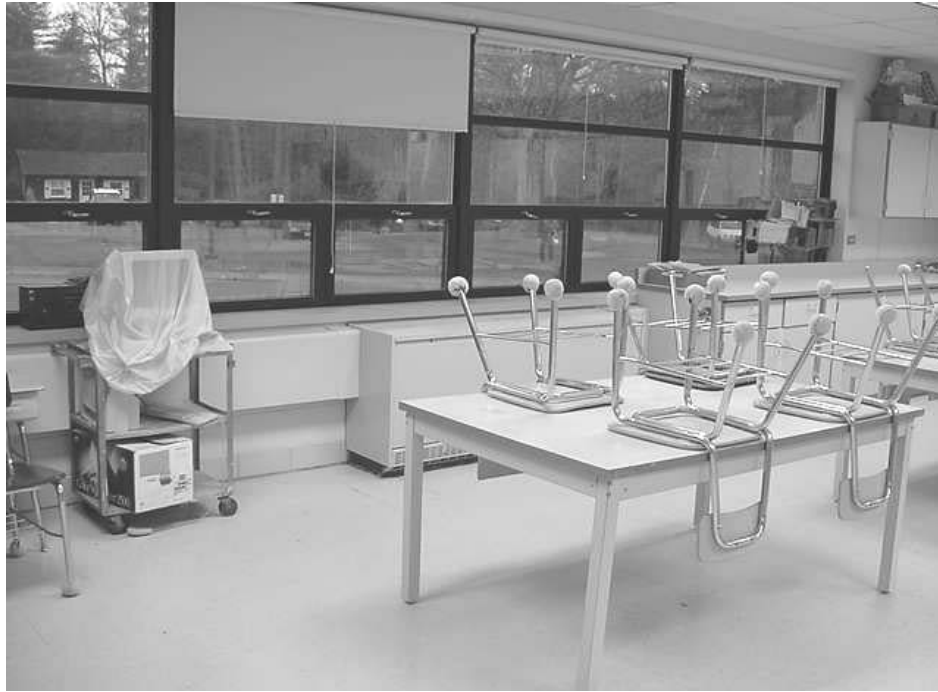
Picture 4

In an effort to reduce noise from sliding chairs, tennis balls had been sliced open and placed on chair legs (see Picture 4). Tennis balls are made of a number of materials that are sources of respiratory irritants. Constant wearing of tennis balls can produce fibers and off-gassing volatile organic compounds (VOCs). Tennis balls are made with a natural rubber latex bladder, which becomes abraded when used as a chair leg pad. Use of tennis balls in this manner may introduce latex dust into the school environment. Some individuals are highly allergic to latex (e.g., spina bifida patients) (SBAA, 2001). It is recommended that the use of materials containing latex be limited in buildings to reduce the likelihood of symptoms in sensitive individuals (NIOSH, 1997). A question and answer sheet concerning latex allergy is attached as [Appendix III](#) (NIOSH, 1998).

Tennis Balls On Chair Legs
